**Flood Control Project Maintenance
Levee Inspections**

Fall 2016 Levee Maintenance Deficiency Summary Report

Reclamation District No. 0554 Walnut Grove

Levee Inspection Report By Mile - Fall 2016

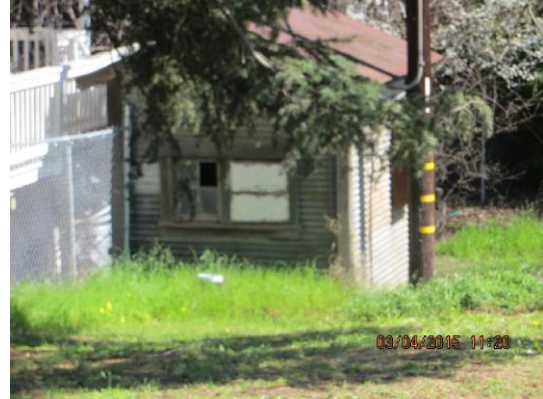
Photo 1 of 2 : UCIP_FA_2016_43726_73282.jpg

LM Start	0.02	Rating **	M	Issue No.	54
LM End	0.02	Issue Type +	En	Location *	WS
Category	Supplemental			GPS Latitude/Longitude	
				Start	End
Item	DWR UCIP Field Study			38.249553 °	38.249553 °
				-121.509954 °	-121.509954 °
DWR ID					
Comment Code					
Inspector Comment					
FS_ID:43726					
DS_ID:18976					
EP_NO: N/A					
Repair Type: Non-Urgent					
Crossing Status: Indicator Found					
UCIP Comments: Need to verify status of crossing with town of Locke.					
FIELD_STRUCT_DESC: Waterline of unknown diameter through the					
levee at unknown depth. Likely a 1 or 2-inch galvanized iron pipe.					
Crosses levee just south of concrete block pumphouse on WS shoulder					
and terminates at well house off LS toe. Gatevalve next to corner of					
pumphouse off LS toe. Drawings depicting approximate location					
available in PN: 12944.					
FS Date: 3/4/2015 4:49:00 PM

Pumphouse off LS toe.

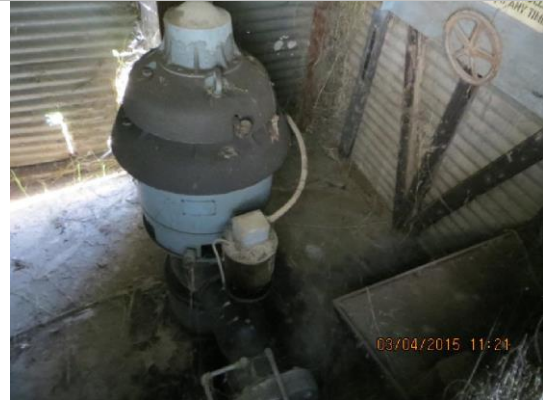
Photo 2 of 2 : UCIP_FA_2016_43726_73281.jpg

Pump over well inside pumphouse on LS toe.

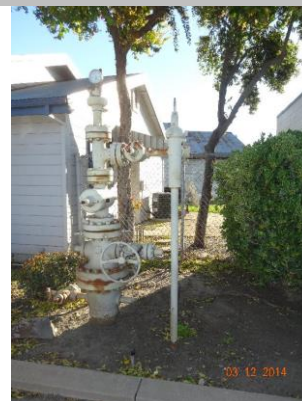
Photo 1 of 1 : UCIP_FA_2016_42146_58463.jpg

LM Start	0.08	Rating **	U	Issue No.	44
LM End	0.08	Issue Type +	En	Location *	WS
Category	Supplemental			GPS Latitude/Longitude	
				Start	End
Item	DWR UCIP Field Study			38.248643 °	38.248643 °
				-121.509850 °	-121.509850 °
DWR ID					
Comment Code					
Inspector Comment					
FS_ID:42146					
DS_ID:20946					
EP_NO: 5607					
Repair Type: Urgent					
Crossing Status: Indicator Found					
UCIP Comments: No markers. Valves abandoned on landward side--					
need to contact owner to determine status of crossing.					
FIELD_STRUCT_DESC: Abandoned three 4-inch steel petroleum pipes					
through the levee, 22.5 feet below the crown. Pipes placed in 8-inch					
pipe casing through the levee and plugged with concrete. Abandoned					
under Permit No. 5607 (1966).					
FS Date: 3/12/2014

Valves located on landward side.

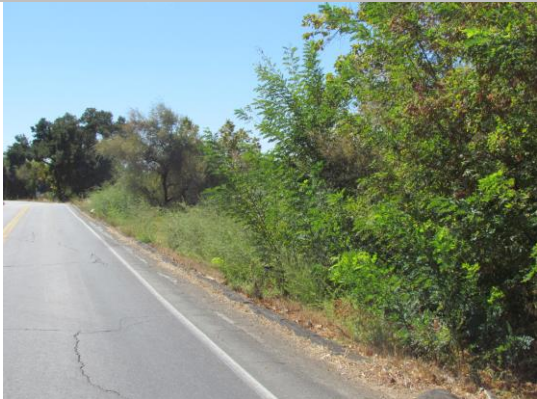
Photo 1 of 1 : FA_2016_RD0554_176_31_20160921_00052.jpg

Looking downstream waterside levee slope from levee mile 0.08-0.30.

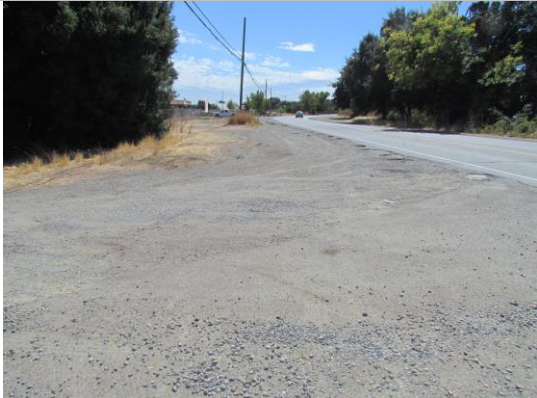
Photo 1 of 1 : FA_2016_RD0554_176_10_20160921_00056.jpg

Looking downstream of the landside levee slope of RD 554.

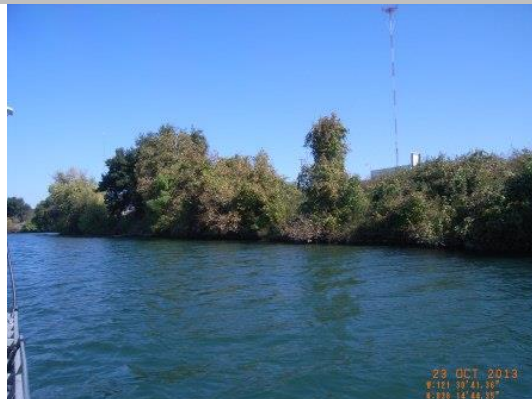
Photo 1 of 2 : FA_2016_RD0554_176_1_20160919_00001.jpg

LM Start	0.26	Rating **	M	Issue No.	1
LM End	0.36	Issue Type +	Ma	Location *	WS
Category	Supplemental			GPS Latitude/Longitude	
				Start	End
Item	2015 USACE Erosion Survey, DRAFT			38.246222 °	38.245017 °
				-121.510878 °	-121.511740 °
DWR ID	DWR_RD0554_01_f_2016_1				
Comment Code					
Inspector Comment					
2009 - Tension cracks on road on top of levee. Erosion into the levee slope and mass failure. 2013 - Short vertical sections at bank toe. 2015: No observed changes. [2015 Site ID: SAC_27-0_L]

USACE 2013 Photo #1

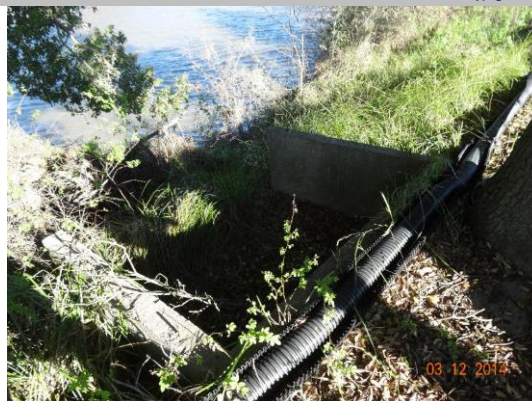
Photo 1 of 2 : UCIP_FA_2016_32018_58469.jpg

LM Start	0.27	Rating **	M	Issue No.	37
LM End	0.27	Issue Type +	En	Location *	WS
Category	Supplemental			GPS Latitude/Longitude	
				Start	End
Item	DWR UCIP Field Study			38.246093 °	38.246093 °
				-121.510731 °	-121.510731 °
DWR ID					
Comment Code					
Inspector Comment					
FS_ID:32018					
DS_ID:20897					
EP_NO: N/A					
Repair Type: Non-Urgent					
Crossing Status: Indicator Found					
UCIP Comments: Unable to determine status of crossing--was crossing removed during erosion repair site in 2007-2009? Need to coordinate with LMA or owner to obtain additional information about crossing.					
FIELD_STRUCT_DESC: *ABANDONED* 6-inch pipe through the levee, 1.0-foot below the crown. Concrete pump pad on the waterward slope.					
O+M manual entry at RM 27.00, 1959.					
FS Date: 3/12/2014

Concrete U wall located on waterward side.

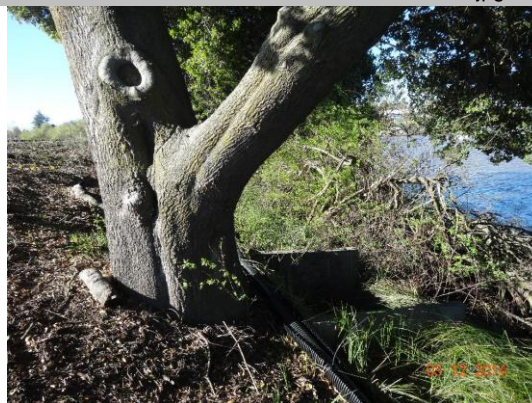
Photo 2 of 2 : UCIP_FA_2016_32018_58468.jpg

Concrete vault located on waterward side. Site is a erosion repair site.

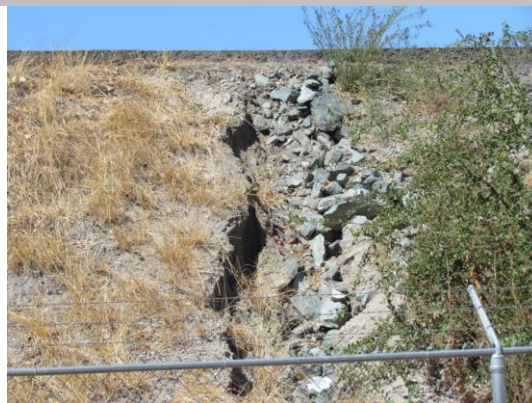
Photo 1 of 2 : FA_2016_RD0554_176_13_20160919_00004.jpg

LM Start	0.32	Rating **	U	Issue No.	13
LM End	0.32	Issue Type +	Ma	Location *	LS
Category	Earthen Levee			GPS Latitude/Longitude	
				Start	End
Item	Erosion / Bank Caving			38.245389 °	38.245389 °
				-121.511085 °	-121.511085 °
DWR ID	DWR_RD0554_01_s_2014_13				
Comment Code					
E2 : Schedule repair of erosion site prior to the next inspection.					
Inspector Comment					
This erosion isn't repaired to date. Needs repairing.

This erosion along the landside levee slope is not new, it was reported two years ago.

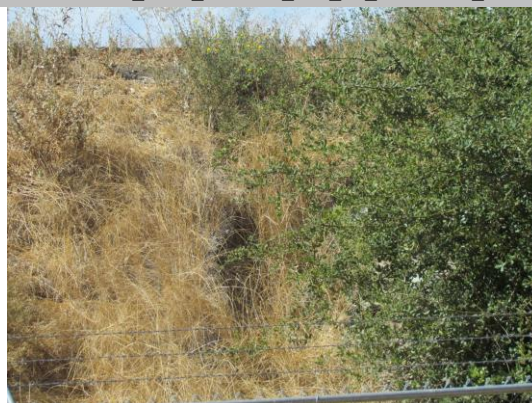
Photo 2 of 2 : FA_2016_RD0554_176_13_20160926_00058.jpg

This erosion site along the landside slope levee 0.32 has been reported and has not been repaired.

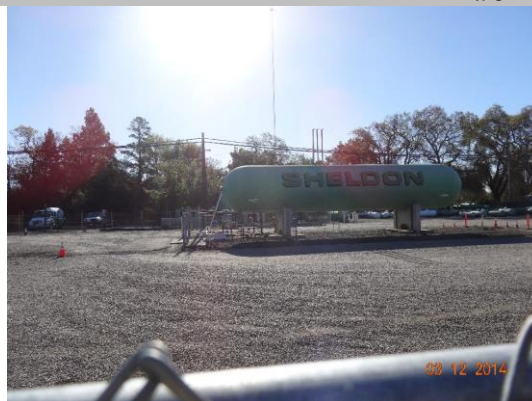
Photo 1 of 1 : UCIP_FA_2016_42143_60800.jpg

LM Start	0.33	Rating **	U	Issue No.	41
LM End	0.33	Issue Type +	En	Location *	LS
Category	Supplemental			GPS Latitude/Longitude	
				Start	End
Item	DWR UCIP Field Study			38.245295 °	38.245295 °
				-121.511274 °	-121.511274 °
DWR ID					
Comment Code					
Inspector Comment					
FS_ID:42143 DS_ID:20922 EP_NO: N/A Repair Type: Urgent Crossing Status: Indicator Found UCIP Comments: No markers found. Need to contact owner to determine status of crossing. Unable to confirm if crossings are still active or if they cross levee. FIELD_STRUCT_DESC: 1 of 3: 3-inch steel fuel line through the levee, 2.7 feet below the crown. (USACE-1959). This entry matches the Drainage or Irrigation Structure referenced in O&M manual (RM 27.20). FS Date: 3/12/2014

Tank found on landward side.

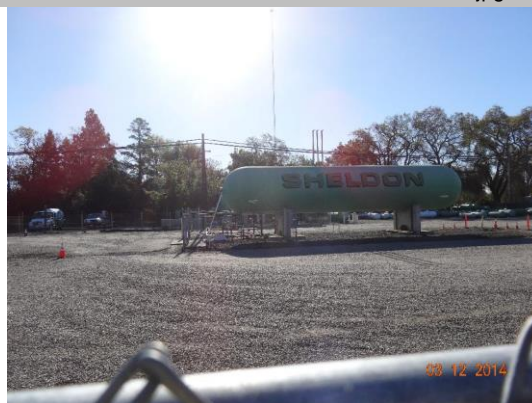
Photo 1 of 1 : UCIP_FA_2016_42144_60801.jpg

LM Start	0.33	Rating **	U	Issue No.	42
LM End	0.33	Issue Type +	En	Location *	LS
Category	Supplemental			GPS Latitude/Longitude	
				Start	End
Item	DWR UCIP Field Study			38.245295 °	38.245295 °
				-121.511274 °	-121.511274 °
DWR ID					
Comment Code					
Inspector Comment					
FS_ID:42144 DS_ID:20932 EP_NO: N/A Repair Type: Urgent Crossing Status: Indicator Found UCIP Comments: No markers found. Need to contact owner to determine status of crossing. Unable to confirm if crossings are still active or if they cross levee. FIELD_STRUCT_DESC: 2 of 3: 3-inch steel fuel line through the levee, 2.7 feet below the crown. (USACE-1959). This entry matches the Drainage or Irrigation Structure referenced in O&M manual (RM 27.20). FS Date: 3/12/2014

Fuel tank located on landward side.

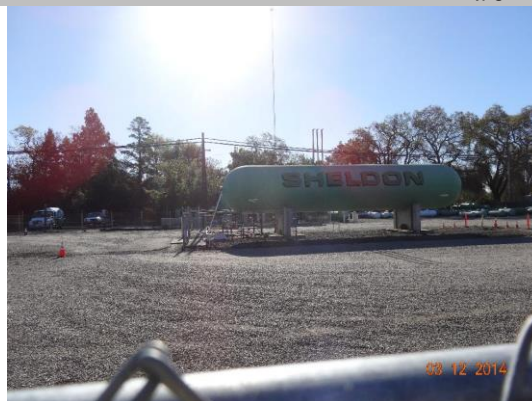
Photo 1 of 1 : UCIP_FA_2016_42145_60802.jpg

LM Start	0.33	Rating **	U	Issue No.	43
LM End	0.33	Issue Type +	En	Location *	LS
Category	Supplemental			GPS Latitude/Longitude	
				Start	End
Item	DWR UCIP Field Study			38.245295 °	38.245295 °
				-121.511274 °	-121.511274 °
DWR ID					
Comment Code					
Inspector Comment					
FS_ID:42145					
DS_ID:20933					
EP_NO: N/A					
Repair Type: Urgent					
Crossing Status: Indicator Found					
UCIP Comments: No markers. Need to contact owner to determine status of crossing. Unable to confirm if crossings are still active or if they cross levee.					
FIELD_STRUCT_DESC: 3 of 3: 3-inch steel fuel line through the levee, 2.7 feet below the crown. (USACE-1959). This entry matches the Drainage or Irrigation Structure referenced in O&M manual (RM 27.20).					
FS Date: 3/12/2014

Fuel tank located on landward side.

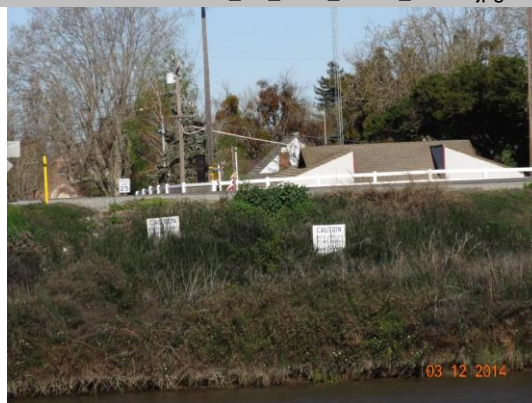
Photo 1 of 2 : UCIP_FA_2016_43694_58063.jpg

Comment Code					
Inspector Comment					
FS_ID:43694					
DS_ID:20899					
EP_NO: 5429					
Repair Type: Non-Urgent					
Crossing Status: Indicator Found					
UCIP Comments: Signs of open cut along crossing--no markers visible on waterward or landward side. Large across channel on right bank berm indicating cable through levee.					
FIELD_STRUCT_DESC: Four 4-inch iron conduits through the levee, at various depths below the crown (3.0-4.9 feet). Each conduit encases a shielded telephone cable. Concrete cutoff wall around pipes on landward levee shoulder. Riser pole off the landward levee toe. (Permit No. 5429-1967) Replacement telephone conduits were pulled through iron conduits under Permit No. 13417 (1983).					
FS Date: 3/4/2015

Signs for conduits visible on right bank across channel. Conduits cross left bank, channel, and right bank.

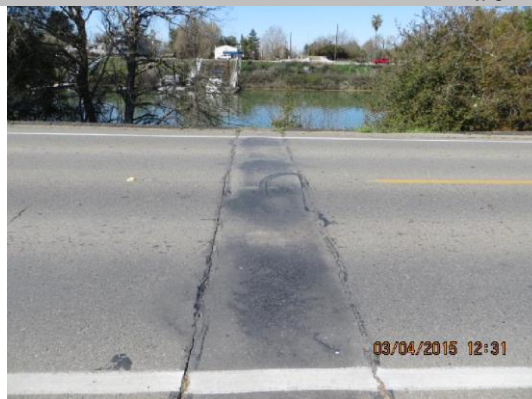
Photo 2 of 2 : UCIP_FA_2016_43694_73221.jpg

Comment Code						
Inspector Comment						
FS_ID:43694						
DS_ID:20899						
EP_NO: 5429						
Repair Type: Non-Urgent						
Crossing Status: Indicator Found						
UCIP Comments: Signs of open cut along crossing--no markers visible on waterward or landward side. Large across channel on right bank berm indicating cable through levee.						
FIELD_STRUCT_DESC: Four 4-inch iron conduits through the levee, at various depths below the crown (3.0-4.9 feet). Each conduit encases a shielded telephone cable. Concrete cutoff wall around pipes on landward levee shoulder. Riser pole off the landward levee toe. (Permit No. 5429-1967) Replacement telephone conduits were pulled through iron conduits under Permit No. 13417 (1983).						
FS Date: 3/4/2015

View of waterside from landside shoulder. Cuts in pavement indicate presence of pipe trench across levee.

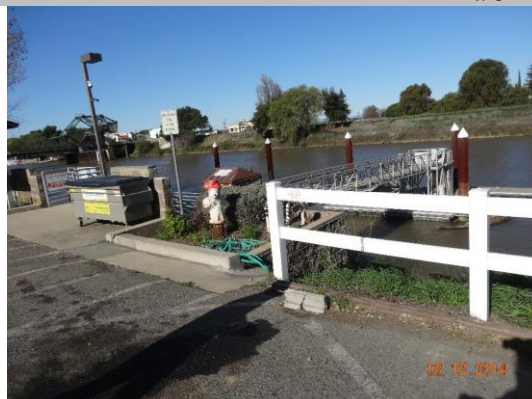
Photo 1 of 2 : UCIP_FA_2016_43734_58085.jpg

Comment Code					
Inspector Comment					
FS_ID:43734 DS_ID:20901 EP_NO: 11155 Repair Type: Non-Urgent Crossing Status: Indicator Found UCIP Comments: Multiple crossings at same location--unable to confirm if crossing matches details under permit 11155. Need to contact owner to obtain additional information about crossing status. FIELD_STRUCT_DESC: 1 of 3: 6-inch pipe through the levee, 5.5 feet below the crown. Pipe retained under ABO No. 11155 (1975). Pipe originally included in O+M manual, 1959, at RM 26.75. Fire hydrant on WS shoulder and valve in cut visible in roadway. Electrical utility box on LS shoulder. Electrical lines visible on WS at ramp. FS Date: 3/12/2014

Multiple lines through levee crown visible on waterward shoulder.

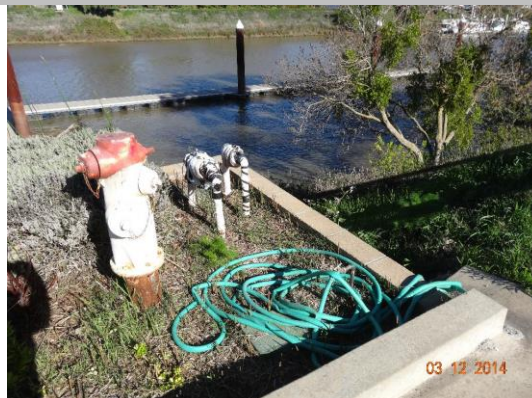
Photo 2 of 2 : UCIP_FA_2016_43734_58083.jpg

Lines visible on waterward side.

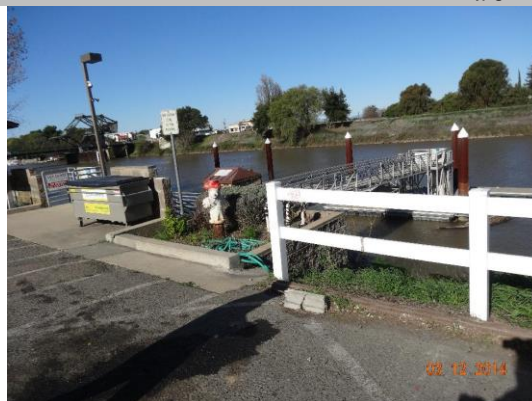
Photo 1 of 2 : UCIP_FA_2016_43735_58097.jpg

Comment Code					
Inspector Comment					
FS_ID:43735 DS_ID:20937 EP_NO: 11155 Repair Type: Non-Urgent Crossing Status: Indicator Found UCIP Comments: Multiple crossings at same location--unable to confirm if crossing matches details under permit 11155. Need to contact owner to obtain additional information about crossing status. FIELD_STRUCT_DESC: 2 of 3: 6-inch pipe through the levee, 5.5 feet below the crown. Pipe retained under ABO No. 11155 (1975).Pipe originally included in O+M manual, 1959, at RM 26.75. Fire hydrant on WS shoulder and valve in cut visible in roadway. Electrical utility box on LS shoulder. Electrical lines visible on WS at ramp. FS Date: 3/5/2015

Multiple crossing visible on waterward shoulder.

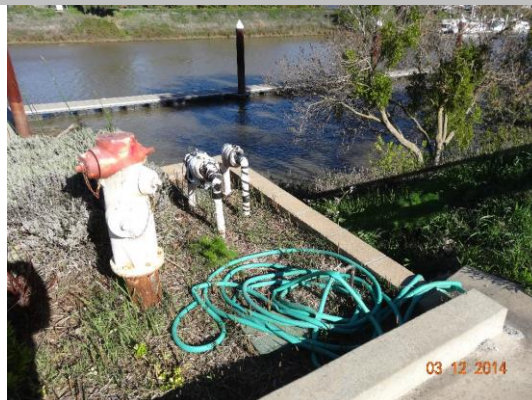
Photo 2 of 2 : UCIP_FA_2016_43735_58095.jpg

Crossings visible on waterward side.

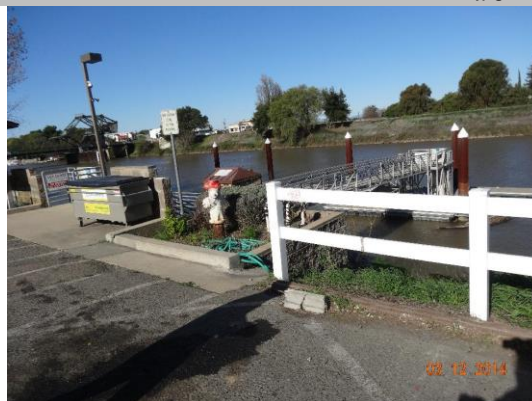
Photo 1 of 2 : UCIP_FA_2016_43736_58091.jpg

Comment Code					
Inspector Comment					
FS_ID:43736 DS_ID:20938 EP_NO: 11155 Repair Type: Non-Urgent Crossing Status: Indicator Found UCIP Comments: Multiple crossings at same location--unable to confirm if crossing matches details under permit 11155. Need to contact owner to obtain additional information about crossing status. FIELD_STRUCT_DESC: 3 of 3: 6-inch pipe through the levee, 10.5 feet below the crown. Pipe retained under ABO No. 11155 (1975).Pipe originally included in O+M manual, 1959, at RM 26.75. Fire hydrant on WS shoulder and valve in cut visible in roadway. Electrical utility box on LS shoulder. Electrical lines visible on WS at ramp. FS Date: 3/5/2015

View of multiple crossings through levee.

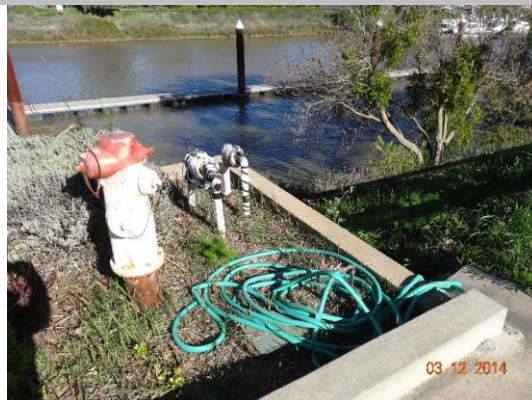
Photo 2 of 2 : UCIP_FA_2016_43736_58089.jpg

Crossings visible on waterward shoulder.

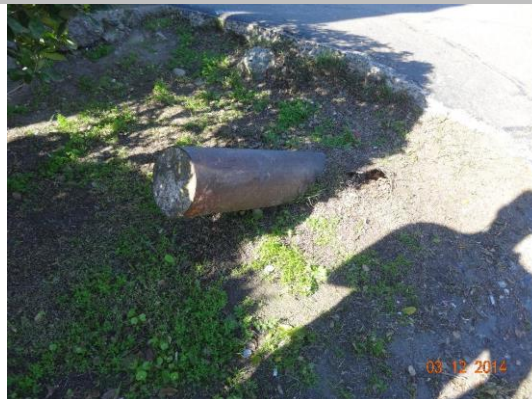
Photo 1 of 1 : UCIP_FA_2016_32020_58473.jpg

LM Start	0.60	Rating **	M	Issue No.	38
LM End	0.60	Issue Type +	En	Location *	WS
Category	Supplemental			GPS Latitude/Longitude	
				Start	End
Item	DWR UCIP Field Study			38.242101 °	38.242101 °
				-121.514086 °	-121.514086 °
DWR ID					
Comment Code					
Inspector Comment					
FS_ID:32020					
DS_ID:20912					
EP_NO: 11154					
Repair Type: Non-Urgent					
Crossing Status: Indicator Found					
UCIP Comments: Unable to confirm if this pipe section is the same one listed under 11154. Need to contact owner to determine status and obtain additional information about crossing.					
FIELD_STRUCT_DESC: *ABANDONED* 8-inch pipe through the levee, 9.8 feet below the crown. Pump on LS toe. Included in O+M manual at RM 26.66. Pipe retained under ABO No. 11154 (1975).					
FS Date: 3/12/2014

Steel pipe filled with concrete visible on landward shoulder.

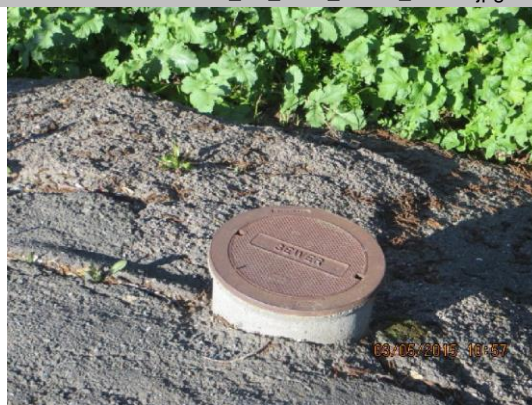
Photo 1 of 2 : UCIP_FA_2016_43805_73320.jpg

LM Start	0.64	Rating **	M	Issue No.	53
LM End	0.64	Issue Type +	En	Location *	WS
Category	Supplemental			GPS Latitude/Longitude	
				Start	End
Item	DWR UCIP Field Study			38.241550°	38.241550°
				-121.514535°	-121.514535°
DWR ID					
Comment Code					
Inspector Comment					
FS_ID:43805 DS_ID:25080 EP_NO: N/A Repair Type: Non-Urgent Crossing Status: Found UCIP Comments: No permit found. Further investigation required. FIELD_STRUCT_DESC: 4-inch Cast iron Sewer pipe through the levee at an unknown depth. Pipe visible on bridge. Sewer cleanout on WS shoulder and cut in pavement visible in roadway. (Permit No. 870, 1941) FS Date: 3/5/2015

Sewer cleanout on WS shoulder.

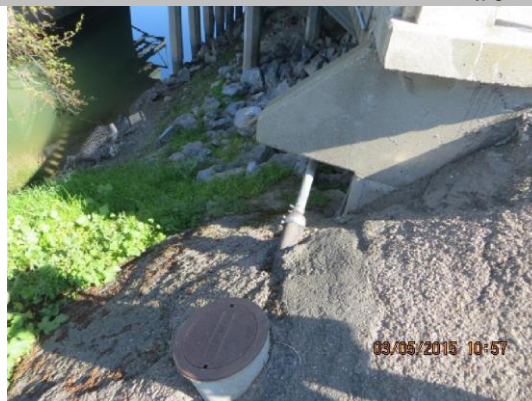
Photo 2 of 2 : UCIP_FA_2016_43805_73321.jpg

LM Start	0.64	Rating **	M	Issue No.	53 (cont)
LM End	0.64	Issue Type +	En	Location *	WS
Category	Supplemental			GPS Latitude/Longitude	
				Start	End
Item	DWR UCIP Field Study			38.241550 °	38.241550 °
				-121.514535 °	-121.514535 °
DWR ID					
Comment Code					
Inspector Comment					
FS_ID:43805 DS_ID:25080 EP_NO: N/A Repair Type: Non-Urgent Crossing Status: Found UCIP Comments: No permit found. Further investigation required. FIELD_STRUCT_DESC: 4-inch Cast iron Sewer pipe through the levee at an unknown depth. Pipe visible on bridge. Sewer cleanout on WS shoulder and cut in pavement visible in roadway. (Permit No. 870, 1941) FS Date: 3/5/2015

Pipe visible at bridge on WS shoulder.

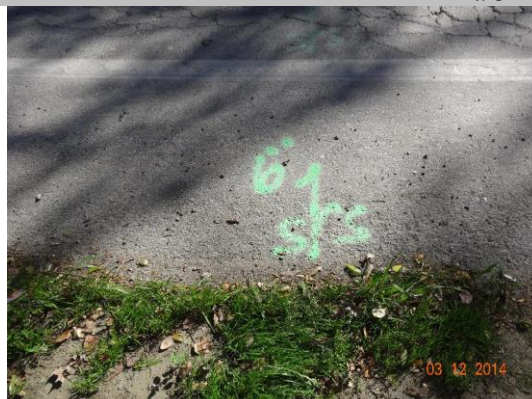
Photo 1 of 2 : UCIP_FA_2016_32021_58475.jpg

LM Start	0.89	Rating **	M	Issue No.	39
LM End	0.89	Issue Type +	En	Location *	LS
Category	Supplemental			GPS Latitude/Longitude	
				Start	End
Item	DWR UCIP Field Study			38.238595 °	38.238595 °
				-121.516945 °	-121.516945 °
DWR ID					
Comment Code					
Inspector Comment					
FS_ID:32021 DS_ID:20941 EP_NO: N/A Repair Type: Non-Urgent Crossing Status: Indicator Found UCIP Comments: Unable to confirm how many sewer lines cross levee. Desk study shows 2 crossings 4-inch not 6 inch. Need to contact owner to confirm status of crossing. FIELD_STRUCT_DESC: 1 of 2: 4-inch clay sewer pipe through the levee, 10.2 feet below the crown. (USACE-1959). This entry matches the Drainage or Irrigation Structure referenced in O&M manual (RM 26.50). FS Date: 3/12/2014 2:06:00 PM

Underground service alert (USA) markers confirming sewer line.

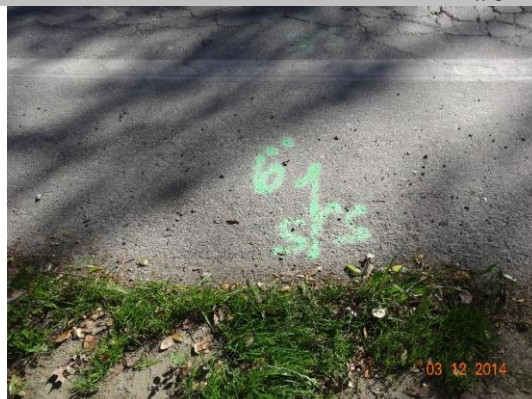
Photo 1 of 2 : UCIP_FA_2016_32022_58480.jpg

LM Start	0.89	Rating **	M	Issue No.	40
LM End	0.89	Issue Type +	En	Location *	LS
Category	Supplemental			GPS Latitude/Longitude	
				Start	End
Item	DWR UCIP Field Study			38.238595 °	38.238595 °
				-121.516945 °	-121.516945 °
DWR ID					
Comment Code					
Inspector Comment					
FS_ID:32022 DS_ID:20942 EP_NO: N/A Repair Type: Non-Urgent Crossing Status: Indicator Found UCIP Comments: Unable to confirm how many sewer lines cross levee. Desk study shows 2 crossings 4-inch not 6 inch. Need to contact owner to confirm status of crossing. FIELD_STRUCT_DESC: 2 of 2: 4-inch clay sewer pipe through the levee, 10.2 feet below the crown. (USACE-1959). This entry matches the Drainage or Irrigation Structure referenced in O&M manual (RM 26.50). FS Date: 3/12/2014

Underground service alert (USA) marker on waterward shoulder for sewer line.

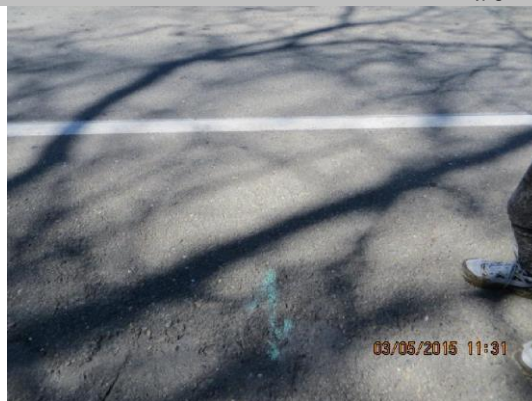
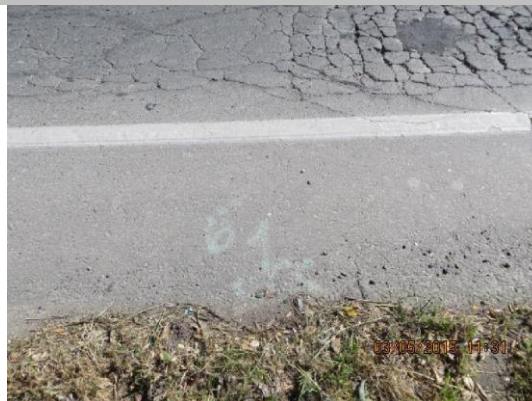
FS_ID:43804
DS_ID:25081
EP_NO: N/A
Repair Type: Non-Urgent
Crossing Status: Indicator Found
UCIP Comments: No permit identified for crossing. Further investigation required.
FIELD_STRUCT_DESC: 6-inch Sewer pipe through the levee at an unknown depth. USAA markings on pavement indicate crossing at center of ramp on LS slope.
FS Date: 3/5/2015

USAA SS marking on LS shoulder.

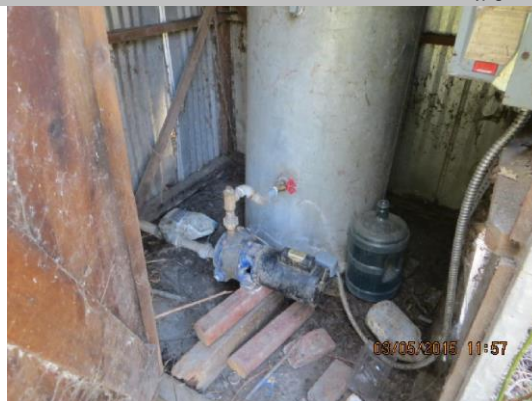
Photo 1 of 2 : UCIP_FA_2016_50027_73243.jpg

FS_ID:50027
DS_ID:20943
EP_NO: 2321
Repair Type: Urgent
Crossing Status: Indicator Found
UCIP Comments: 7/25/2016 Coordinated with District Engineer, Gilbert Labrie with DCC Engineering. He will coordinate with owner. (DWR UCIP - omagana)3/05/2015 Pipe leak at landside toe 23-ft upstream from pumphouse on LS toe. (DWR UCIP - omagana)
FIELD_STRUCT_DESC: 1.0-inch steel domestic water pipe through the levee, 1.5 feet below the crown. Shut off valve on the waterside (WS) and at the pumphouse downstream 170 feet on landside (LS) toe. Pump in pumphouse on LS toe. An additional 1.5-inch galvanized iron drinking water pipe runs from pumphouse along LS toe parallel to levee. (Permit No. 2321, 1957 - Clara B. Salisbury).
FS Date: 7/25/2016

Pressurized tank, meter and pump in pumphouse on LS toe.

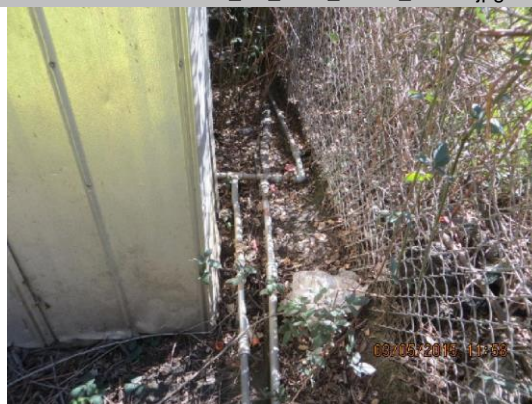
Photo 2 of 2 : UCIP_FA_2016_50027_73244.jpg

A 1-inch and a 1.5-inch galvanized iron drinking water pipe with shutoff valves at pumphouse on LS toe.

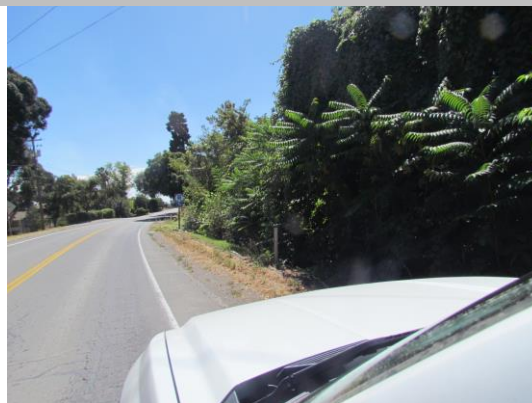
Photo 1 of 1 : FA_2016_RD0554_176_34_20160921_00055.jpg

Looking downstream from levee mile 1.01-1.08 waterside slope.

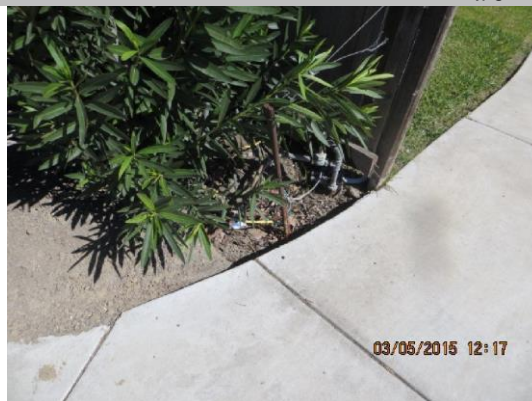
Photo 1 of 2 : UCIP_FA_2016_43810_73328.jpg

LM Start	1.09	Rating **	M	Issue No.	46
LM End	1.09	Issue Type +	En	Location *	WS
Category	Supplemental			GPS Latitude/Longitude	
				Start	End
Item	DWR UCIP Field Study			38.235743 °	38.235743 °
				-121.517032 °	-121.517032 °
DWR ID					
Comment Code					
Inspector Comment					
FS_ID:43810 DS_ID:25083 EP_NO: N/A Repair Type: Non-Urgent Crossing Status: Found UCIP Comments: No permit identified for crossing. Further investigation required. FIELD_STRUCT_DESC: Two 1-inch conduits through the levee 1-foot below the crown. Valves appear to be installed on LS shoulder. Dock on WS slope. FS Date: 3/5/2015

Pipes visible at LS shoulder next to driveway.

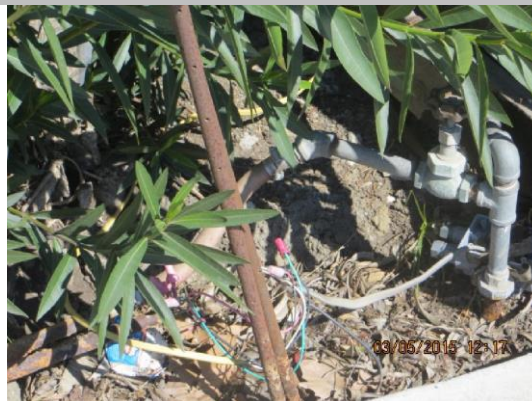
Photo 2 of 2 : UCIP_FA_2016_43810_73329.jpg

Pipes and valves visible on LS shoulder.

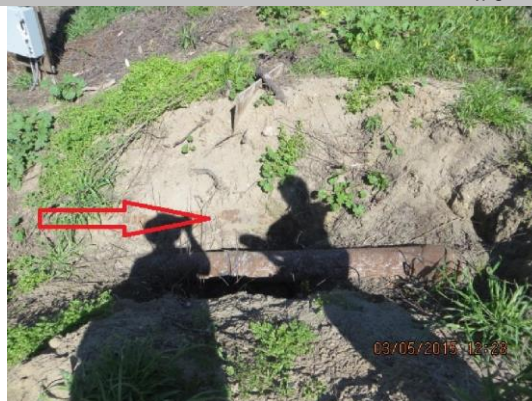
Photo 1 of 1 : UCIP_FA_2016_43747_73286.jpg

LM Start	1.11	Rating **	M	Issue No.	49
LM End	1.11	Issue Type +	En	Location *	WS
Category	Supplemental			GPS Latitude/Longitude	
				Start	End
Item	DWR UCIP Field Study			38.235429 °	38.235429 °
				-121.517169 °	-121.517169 °
DWR ID					
Comment Code					
Inspector Comment					
FS_ID:43747 DS_ID:20930 EP_NO: N/A Repair Type: Non-Urgent Crossing Status: Found UCIP Comments: Pipe should be abandoned properly. Pipe was visible just upstream of other pipe that was exposed for repair on WS slope. FIELD_STRUCT_DESC: *ABANDONED* 8-inch steel irrigation pipe through the levee, 3.7-feet below the crown. Pump on waterward side. (USACE-1959). This entry matches the Drainage or Irrigation Structure referenced in O&M manual (RM 26.10). Pipe buried/abandoned in place. FS Date: 3/5/2015

Abandoned pipe was exposed on WS slope when a trench was opened to repair the other 8-inch pipe at the site.

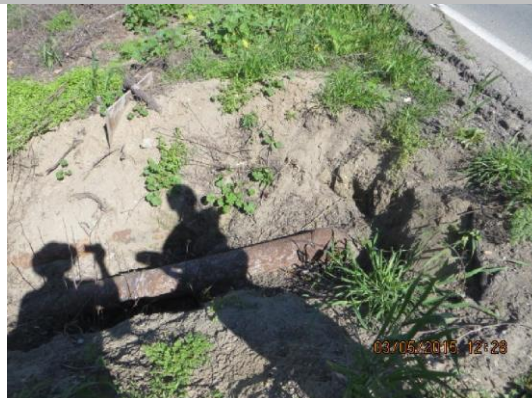
Photo 1 of 2 : UCIP_FA_2016_43748_73289.jpg

LM Start	1.11	Rating **	M	Issue No.	50
LM End	1.11	Issue Type +	En	Location *	WS
Category	Supplemental			GPS Latitude/Longitude	
				Start	End
Item	DWR UCIP Field Study			38.235422 °	38.235422 °
				-121.517172 °	-121.517172 °
DWR ID					
Comment Code					
Inspector Comment					
FS_ID:43748					
DS_ID:20911					
EP_NO: 5023					
Repair Type: Non-Urgent					
Crossing Status: Found					
UCIP Comments: Pipe in open trench on WS slope and exposed on LS shoulder. Pipe repair on WS may indicate problem with pipe. Pipe missing air releif valve on LS shoulder. Distribution box on LS toe abandoned.					
FIELD_STRUCT_DESC: 8-inch steel pipe through the levee, 2.4 feet below the crown. Cutoff wall around center of pipe. Air-relief valve on landward levee shoulder. Pump on waterward slope. Concrete distribution box on LS toe (Permit No. 5023-1965).					
FS Date: 3/5/2015

Pipe in open trench on WS slope. Repair patch on pipe.

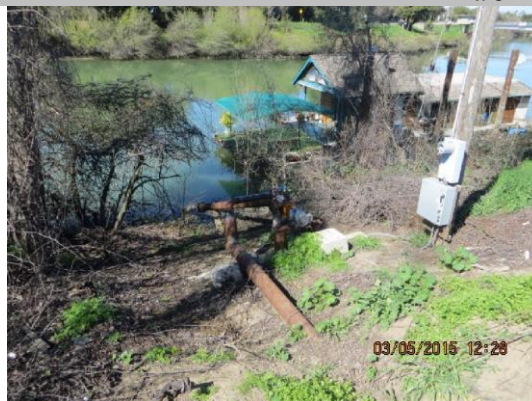
Photo 2 of 2 : UCIP_FA_2016_43748_73288.jpg

LM Start	1.11	Rating **	M	Issue No.	50 (cont)
LM End	1.11	Issue Type +	En	Location *	WS
Category	Supplemental			GPS Latitude/Longitude	
				Start	End
Item	DWR UCIP Field Study			38.235422 °	38.235422 °
				-121.517172 °	-121.517172 °
DWR ID					
Comment Code					
Inspector Comment					
FS_ID:43748 DS_ID:20911 EP_NO: 5023 Repair Type: Non-Urgent Crossing Status: Found UCIP Comments: Pipe in open trench on WS slope and exposed on LS shoulder. Pipe repair on WS may indicate problem with pipe. Pipe missing air releif valve on LS shoulder. Distribution box on LS toe abandoned. FIELD_STRUCT_DESC: 8-inch steel pipe through the levee, 2.4 feet below the crown. Cutoff wall around center of pipe. Air-relief valve on landward levee shoulder. Pump on waterward slope. Concrete distribution box on LS toe (Permit No. 5023-1965). FS Date: 3/5/2015

Pipe exposed on WS slope. pump, shutoff valve, and meter on pole on WS slope.
